CASE STUDY/RIVERWALK CASINO

1046 Warrenton Rd, Vicksburg, MS 39180

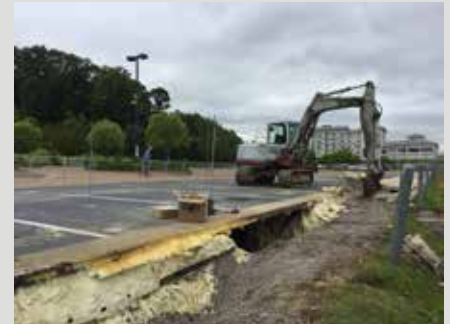
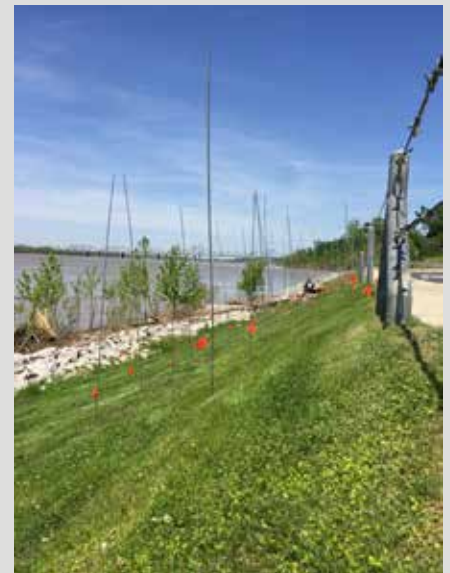
The casino property has a large parking lot and sidewalk adjacent to the river. Over time, the soil under the parking lot grew weak due to poor compaction and water erosion. This caused the concrete structures atop the soil to sink. The sinking concrete put strains on the property drainage system, that ultimately resulted in a pipe joint failure. This pipe failure caused the flowing drain water to rush freely under the parking lot. The water then forced its way into a concrete basin where it began pulling away soil and rocks from the Mississippi River Bank, creating a large void, and causing the river bank to collapse. After two failed repair attempts, utilizing a full demolition and replacement of soil and concrete, Churchill Downs and Riverwalk Casino decided it was time to fix the problem permanently. They called the soil stabilization professionals at Helms Polyfoam.

Helms Polyfoam, along with a forensic engineering firm, conducted a thorough site evaluation to determine not only how to fix the current problem, but how to stop it from recurring. First, the main void was filled with AP 475 to create a strong foundation for heavy equipment to work. Second, all concrete structures were stabilized by utilizing deep injection methods at pre-determined points surrounding problem areas. Next, we performed a multilayer soil squeeze in a grid pattern, spanning 110' of the Mississippi River bank. This soil squeeze compacted all weak soils that collapsed as well as created a water impermeable barrier along the bank. After this, we performed the exact same method on the opposite side of the void to ensure stabilization of soils throughout the entire problem area. We monitored the entire process with zip levels and rotating laser levels. Once we reached positive pressures, the structures as well as the levee began to rise to an even height, giving us confirmation that the soil was stabilized. With the void filled and the soil stabilized, the parking lot was ready for new sidewalks and a fresh layer of landscape to further prevent erosion.
