CASE STUDY/spillway leak seal

FLORENCE, MISSISSIPPI

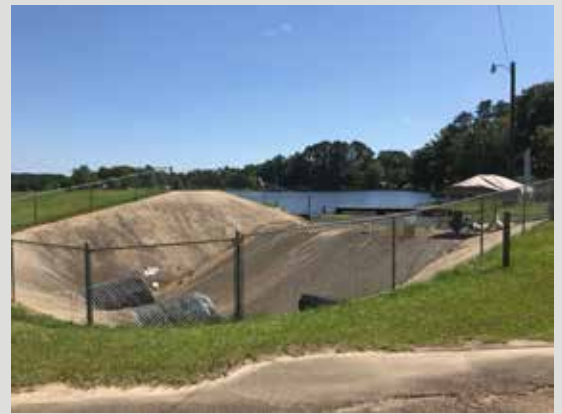
This lake has a spillway to maintain appropriate water levels. It is constructed of concrete and is approximately 50' wide with elevated sides and 70' long with a sloping grade to promote drainage. At the end of the concrete spillway are two 48" culvert pipes to drain the water underneath the roadway. We must say, this spillway construction was top notch and the repair is not related to a design flaw, but high amounts of continuous flooding. A resident found a small void forming along one side of the spillway. They immediately built a sandbag dam in front of the void and called Helms Polyfoam to evaluate the situation. The void was due to water undermining the spillway. As we know, when water finds a weak point in soil, it is tenacious and will continue to create a tunnel. Water was tunneling all the way under the 70' spillway and exiting at the mouth of one culvert pipe and in the middle of the other.

Priority #1 was to stop the leak and stop it quickly before it continued to create voids underneath and potentially collapse the spillway. High expansion, structural, hydrophobic, polyurethane resins were injected underneath the spillway at the water's initial intrusion point. Within 5 minutes, the water leak was stopped to a mere trickle! Hydrophobic, expanding resins can make quick work of even the highest flow leak! Once the leak was stopped injections were made in grid pattern through all suspected water paths. This style of injection ensured all voids created by the water were filled and sealed. Priority #2 consisted of preventative maintenance and further stabilization of the area. For this application, hydrophobic, permeating, polyurethane resins were used. The adjustable set time and hydrophobic properties make this style resin great for tracking and sealing even the smallest of leaks. This resin was injected underneath the slab across the entire mouth of the spillway and a slow set time to ensure maximum travel before curing.
