CASE STUDY/Ramp Repair

Brandon Amphitheater

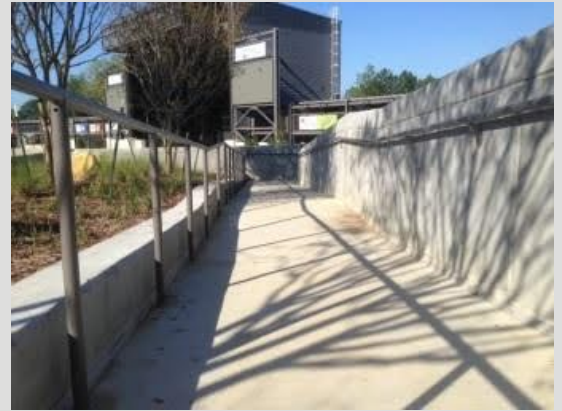
The Brandon Amphitheater has two pedestrian ramps showing signs of slab drop and settling. The drop on the ramp descending from the top tier seating level (Ramp #1) appears to be approximately 3 inches while the second ramp (Ramp #2) appears to have settled 1 inch from original pour height.

The 6'x12' section between these ramps has also dropped approximately 3 inches.

After conducting a site evaluation and speaking with superintendent for Thrash Commercial Greg Moseley, it is our opinion that the slabs have settled due to poor soil compaction and/or shifting in the material used to build up the ramp section.

Helms Polyfoam recommends a void fill, slab lift, and soil/material stabilization using our deep injection methods. 5/8" holes will be drilled throughout the slabs to allow for polyurethane resins to be pressure injected directly to the problem areas. Metal rods will then be bored to a depth of approximately 4' where we will begin the injection process. As the two component resins mix under the slab, they will begin to react and expand, creating a "squeeze" application that will compact and fill all voids present. This will provide a stable base to help achieve slab lift.

As mentioned above, we estimate Ramp # 1 to require 3" of lift and Ramp #2 to require 1" while both ramps will require stabilization of the material under the ramps to prevent further drop and settling.
