CASE STUDY/TABOR MANAGEMENT

STARKVILLE, MISSISSIPPI

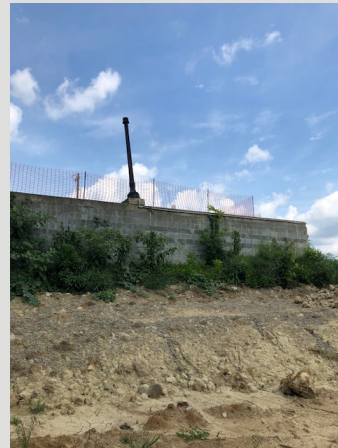
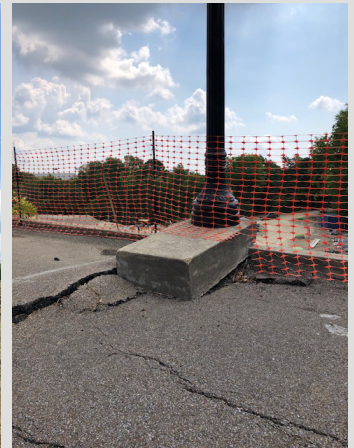
Tabor Management manages several properties in the iconic Cotton District in Starkville, MS. Next to one of the properties was a major construction project for a new development. As with most new developments, this project required a large excavation phase where soil was hauled out by the truck load. When the soil was pulled away, the soil under the parking of Tabor Management's property lost support. This in addition to poor compaction and vibrations from all of the excavation equipment led to erosion under the parking lot. This erosion caused the parking lot to collapse, rendering it useless until repaired.

After determining the extent of the erosion in regards to parking lot depth, Helms Polyfoam was able to pin point the precise locations to inject our high density, structural, polyurethane resins, and begin the stabilization process. A deep injection method was used through ½" rods driven in a grid pattern throughout the parking lot to cover the failed areas. Using this method, compaction was achieved at depths that "tear out and replace" methods cannot. The grid pattern mentioned above completes what is known as a "soil squeeze" to not only compact the soil, but to also lock the soil together under the parking lot. Once this solid foundation was completed, Tabor Management was able to overlay their asphalt parking lot and begin utilizing the space again, just in time for the upcoming school year.
